# Manhole Inspection Summary

Manhole # S39A\_\_038MH

Insp Date: **11/5/08 10:27 AM**

**Location** Address: **1110 orleans st**

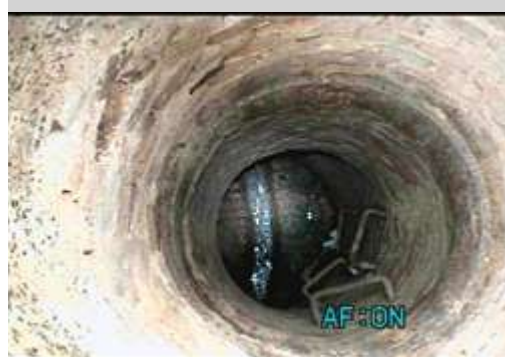
Top View

Comments **cover doesnt fit in frame**

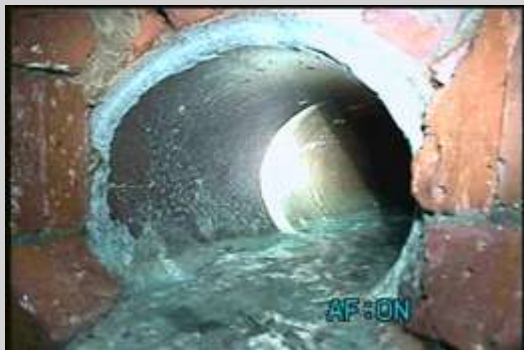
12 O'Clock Outflow

8 in. Circular Gravity Sewer  
Pipe Out @ 12 O'Clock

Invert Depth: **12.70** (ft.) Flow Characteristics: **Slow**

Infiltration: **None** Pipe Seal Cond: **Unknown**

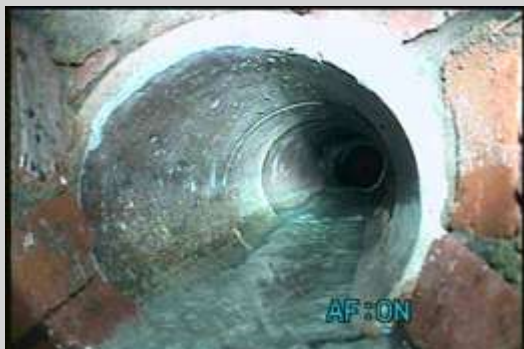
7 O'Clock Inflow

8 in. Circular Gravity Sewer  
Pipe In @ 7 O'Clock

Infiltration: **None** Pipe Seal Cond: **Unknown**
